Proceedings of the  
International Conference on

# Steel Structures of the 2000's

# **Temperature-initiated buckling phenomena in stainless steel flue gas liners of double-skin chimneys**

**Abstract:** Buckling damage in stainless steel liners of double-skin steel chimneys have repeatedly been detected. Four case studies are presented. The main cause for these shell buckling phenomena are “thermal imperfections“ in the form of temperature strands.

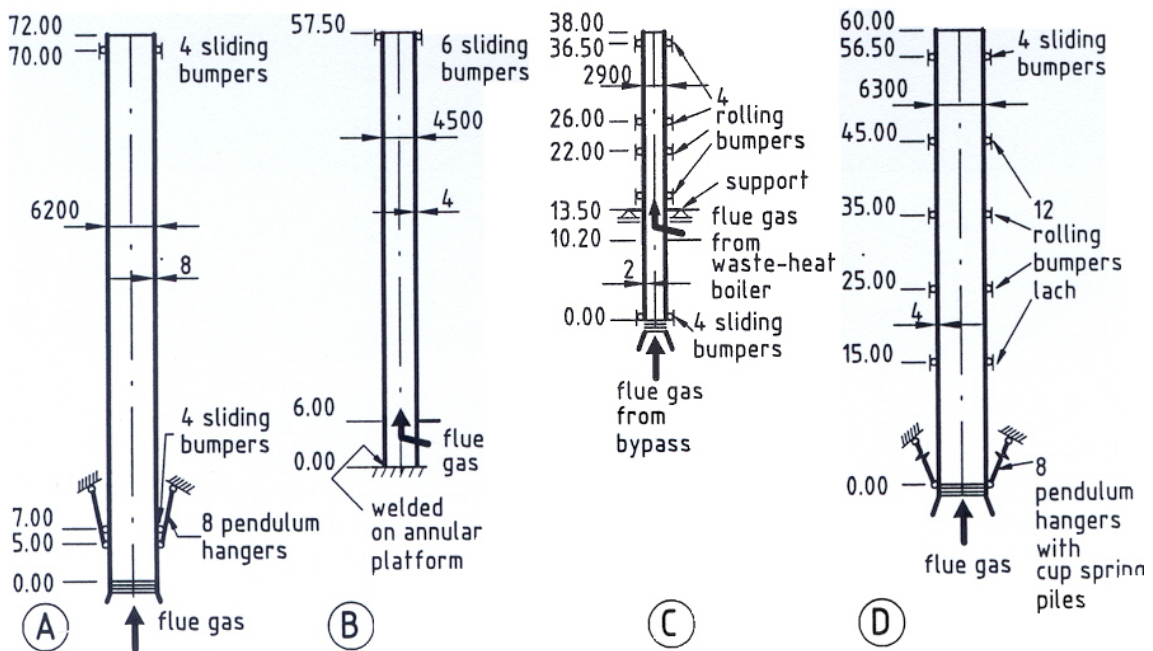
**Fig. 1.** Systems of the four liner cases

The four liners are supported and laterally guided by different constructional methods. Figure 1 shows schematically their structural systems, together with the flue gas entry situations which are also quite different. However, all of them represented, looked at as vertical tubular beams, statically indeterminate systems. The four cases are now discussed individually.

In this chimney (see Fig. 1A) both of the two flue gases, the hot one from the bypass and the “cool” one from the waste-heat boiler, enter the liner concentrically from below. During combined operation, they are mixed by means of special baffle devices before entering the liner. It was therefore expected by the design engineers that heating up and cooling down of the liner take place in a uniform manner. None the less, the damage described hereafter occurred. Obviously there were still unavoidable temperature strands in the gas flow which yielded temperature differences between opposite sides of the liner tube.

Damage was found in the supported region of the liner. They included column buckling (!) and plastic overtensioning, respectively, of opposite hanger tie rods, a large inward buckle at a circumferential weld above the overtensioned hangers, and out-of-effectiveness of the sliding guides above the supported section. Fig. 2 demonstrates the damage process: The hanger-supported section represented for the vertical tubular beam a full bending restraint (Fig. 2b). The temperature difference between opposite liner walls produced a foot bending moment  $M_E$ . An elementary analysis shows that an assumed linear gradient  $\Delta T$  across the diameter (see Fig. 2a) having an order of magnitude as small as 15K and decreasing to zero at the top of the liner would cause the observed damage (phase 1). For further increase of  $\Delta T$  the statical system acted determinately (Fig. 2a); the tube could now deform unrestrained within the limits of the ventilated space between structural shell and liner (phase 2). The lower sliding bumpers then lost their horizontally supporting effect (can not be deepened here), and the tube could deform even more (phase 3).

Some medium size buckles were found neighbouring close to the duct entry after the first testing operation under mixed flue gas conditions. Their inward depths were 10mm on average, their shapes were typical for local shell buckling modes under axial membrane compressive stresses. An elementary buckling analysis showed that a temperature gradient across the diameter of  $\Delta T = \text{ca. } 20\text{-}30\text{K}$  would be enough to produce the necessary tubular bending moment  $M_E$  for this local buckling. With these buckles present, the liner would behave as a statically determinate tubular beam system (see Fig. 2a); one could say that the liner would have produced its wanted “hinge” itself. After another four months testing operation period, the buckles had not enlarged. Obviously the flue gas mixing devices are in this case efficient enough to keep the unavoidable temperature strands down to the mentioned level. It was decided to leave the buckles in the wall and to check their depths after every heating period: As long as they do not enlarge they are not a problem from the standpoint of safety.

This is the only one of the four cases where the acting temperature gradient  $\Delta T$  did not have the character of a “thermal imperfection” but was a logical consequence of the operational design (see Fig. 1C). When, after a bypass operation period, switching to heating operation, the uniformly hot liner is directly acted upon by the cool waste-heat boiler gas from the side. This causes a rather high, quasi well-defined temperature gradient  $\Delta T$ . It produced in fact two heavily buckled regions in the liner wall - just above the vertical support and just below the second lateral rolling guides - and minor buckles at the third lateral guides. Considering the threefold statically indeterminate system and the probable decrease of  $\Delta T$  towards the top, the observed buckling configuration is logical.

A number of typical axial compression buckles were found, rather irregularly distributed over the lower third of the liner. It is supposed that small temperature strands (15K would be enough!), together with eventual radial restraint at the rolling bumpers, and in combination with the unusually high self weight utilization (it amounts to 40 to 60% of the buckling stress, see Table 1), caused the severe buckling damages. To the knowledge of the authors, the liner was completely replaced by a considerably thicker structure.

The essential feature of the proposed remedial measures is to make the liner a statically determinate tubular system: by installing two corrugated plate compensators with low angular stiffness at the positions of the buckling damage which provides the liner with its “wanted” hinges, and by leaving out the upper one of the two intermediate rolling bumper assemblies.

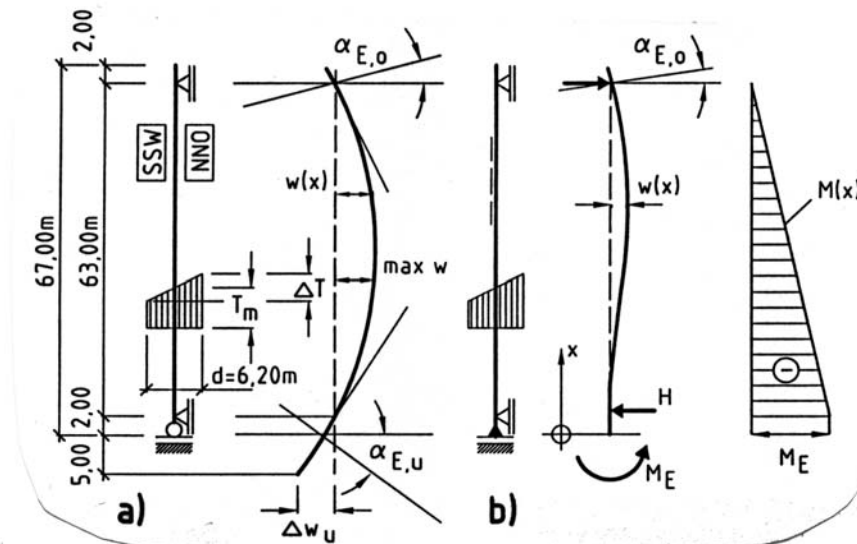
Fig 2. Statical systems of the liner A as a tubular beam

In the course of the investigation after the damage occurred it could be proved by video inspection of the ventilated space from the top of the chimney that no serious pressing contact between the outer surface of the liner insulation and the inner surface of the structural shell had taken place. Therefore the remedial measures could be restricted to the necessary repairs and - the main step - to reconstructing the liner support by including cup spring piles between the hangers and their bearings. That lead to the statically determinate beam system of Fig. 2a from the very beginning. The repaired chimney has
