Steel Structures of the 2000's

Temperature-initiated buckling phenomena in stainless steel flue gas liners of double-skin chimneys

Abstract: Buckling damage in stainless steel liners of double-skin steel chimneys have repeatedly been detected. Four case studies are presented. The main cause for these shell buckling phenomena are “thermal imperfections“ in the form of temperature strands.

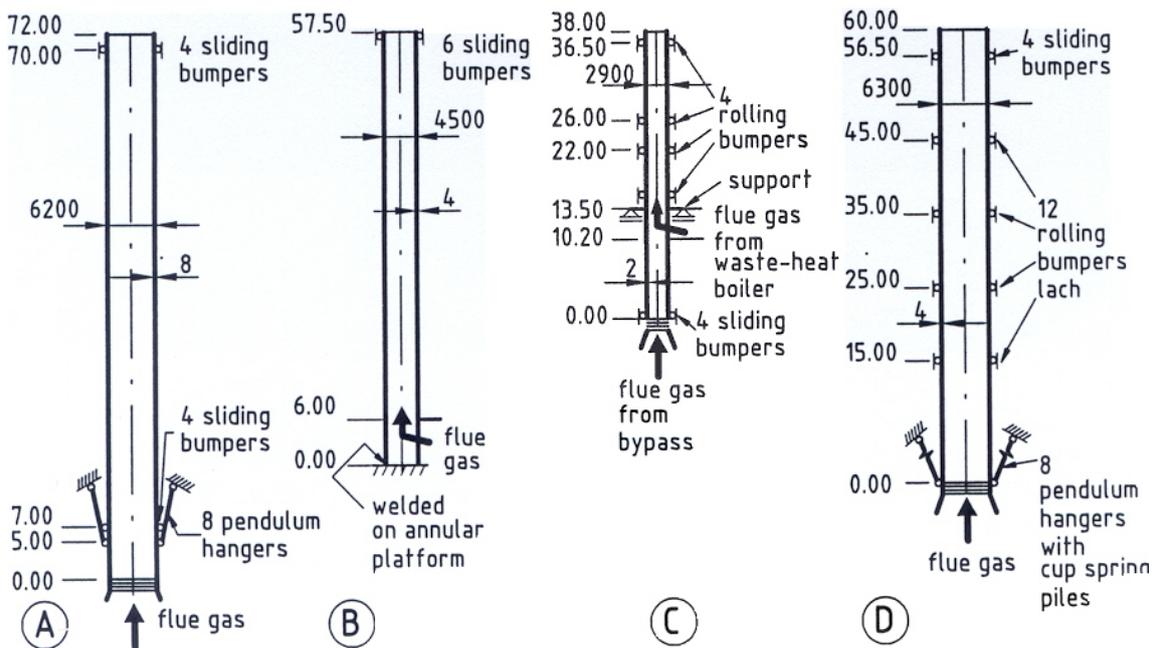
Fig. 1. Systems of the four liner cases

In this chimney (see Fig. 1A) both of the two flue gases, the hot one from the bypass and the “cool“ one from the waste-heat boiler, enter the liner concentrically from below. During combined operation, they are mixed by means of special baffle devices before entering the liner. It was therefore expected by the design engineers that heating up and cooling down of the liner take place in a uniform manner. None the less, the damage described hereafter occurred. Obviously there were still unavoidable temperature strands in the gas flow which yielded temperature differences between opposite sides of the liner tube.

Damage was found in the supported region of the liner. They included column buckling (!) and plastic overtensioning, respectively, of opposite hanger tie rods, a large inward buckle at a circumferential weld above the overtensioned hangers, and out-of-effectiveness of the sliding guides above the supported section. Fig. 2 demonstrates the damage process: The hanger-supported section represented for the vertical tubular beam a full bending restraint (Fig. 2b). The temperature difference between opposite liner walls produced a foot bending moment M_E . An elementary analysis shows that an assumed linear gradient ΔT across the diameter (see Fig. 2a) having an order of magnitude as small as 15K and decreasing to zero at the top of the liner would cause the observed damage (phase 1). For further increase of ΔT the statical system acted determinately (Fig. 2a); the tube could now deform unrestrained within the limits of the ventilated space between structural shell and liner (phase 2). The lower sliding bumpers then lost their horizontally supporting effect (can not be deepened here), and the tube could deform even more (phase 3).

This liner (see Fig. 1B) is, as far as the statical tubular beam system is concerned, quite similar to case A. The two flue gases are also mixed by special devices before entering the liner, and the liner is also bending-restrained at its support and has only one lateral guide at the very top. However, contrary to case A, the duct entry is sideways through a 6m high opening in the liner wall, and the base support is realized by simply welding the lower end, just below the duct entry, continuously along its circumference to an annular resting platform which is carried by brackets welded to the structural shell.

Some medium size buckles were found neighbouring close to the duct entry after the first testing operation under mixed flue gas conditions. Their inward depths were 10mm on average, their shapes were typical for local shell buckling modes under axial membrane compressive stresses. An elementary buckling analysis showed that a temperature gradient across the diameter of $\Delta T = \text{ca. } 20\text{-}30\text{K}$ would be enough to produce the necessary tubular bending moment M_E for this local buckling. With these buckles present, the liner would behave as a statically determinate tubular beam system (see Fig. 2a); one could say that the liner would have produced its wanted “hinge” itself. After another four months testing operation period, the buckles had not enlarged. Obviously the flue gas mixing devices are in this case efficient enough to keep the unavoidable temperature strands down to the mentioned level. It was decided to leave the buckles in the wall and to check their depths after every heating period: As long as they do not enlarge they are not a problem from the standpoint of safety.

This is the only one of the four cases where the acting temperature gradient ΔT did not have the character of a “thermal imperfection” but was a logical consequence of the operational design (see Fig. 1C). When, after a bypass operation period, switching to heating operation, the uniformly hot liner is directly acted upon by the cool waste-heat boiler gas from the side. This causes a rather high, quasi well-defined temperature gradient ΔT . It produced in fact two heavily buckled regions in the liner wall - just above the vertical support and just below the second lateral rolling guides - and minor buckles at the third lateral guides. Considering the threefold statically indeterminate system and the probable decrease of ΔT towards the top, the observed buckling configuration is logical.

The lower end of this liner (see Fig. 1D) is supported by a rim of pendulum hangers with interposed cup spring piles - a technique that has proved to be a reasonable way to avoid tubular bending restraint at the base support (see case A). As a measure to avoid also lateral restraint at the vertically supported section, the first lateral guidance is located as high as 15m above the lower end. On the other hand, four further equidistant rolling bumper assemblies provided rather tight guidance for the upper three quarters of the liner. The assumed temperature configuration included a conservatively large lateral temperature gradient $\Delta T = 300\text{K}$ at the gas entry, but an unconservatively optimistic zero gradient from the first lateral guides on.

A number of typical axial compression buckles were found, rather irregularly distributed over the lower third of the liner. It is supposed that small temperature strands (15K would be enough!), together with eventual radial restraint at the rolling bumpers, and in combination with the unusually high self weight utilization (it amounts to 40 to 60% of the buckling stress, see Table 1), caused the severe buckling damages. To the knowledge of the authors, the liner was completely replaced by a considerably thicker structure.

The essential feature of the proposed remedial measures is to make the liner a statically determinate tubular system: by installing two corrugated plate compensators with low angular stiffness at the positions of the buckling damage which provides the liner with its “wanted” hinges, and by leaving out the upper one of the two intermediate rolling bumper assemblies.
